## Inspector Neto Home Inspections

### Report Information

Property Address 12345 Street, Detroit, MI 48201

Inspection Date 03/07/2010

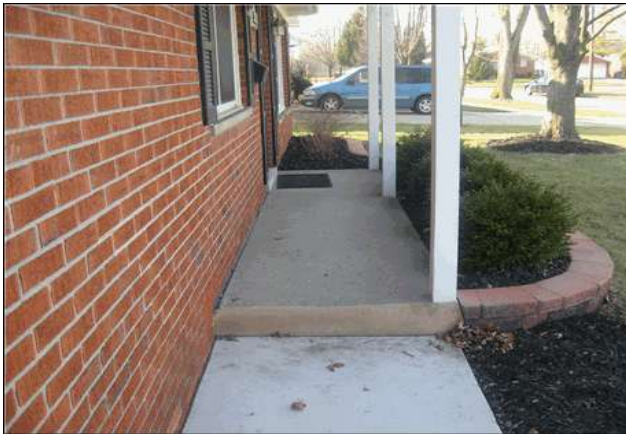
2.1.3 Rail Condition

No rail installed

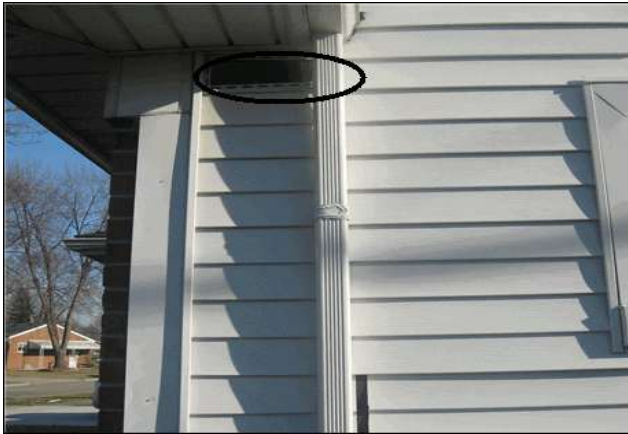
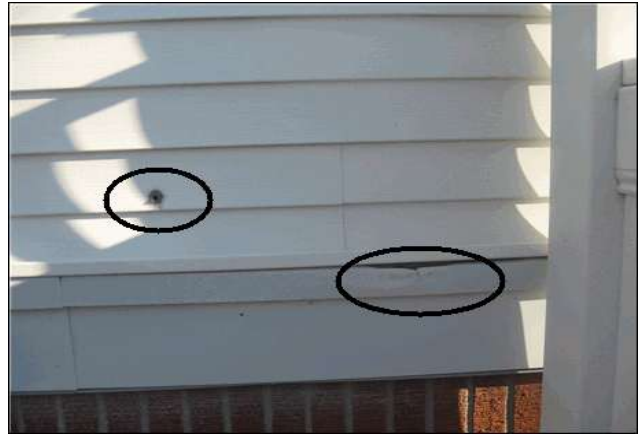
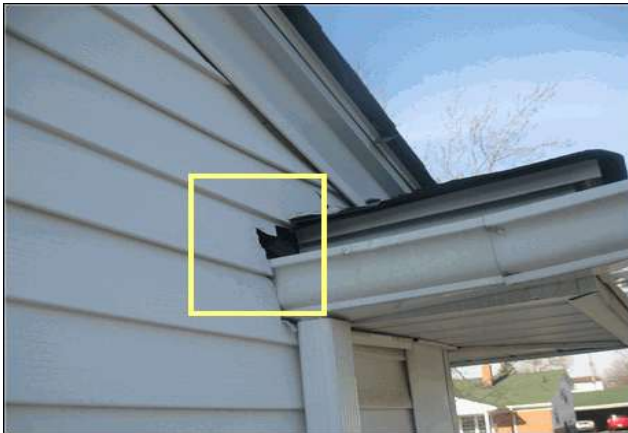
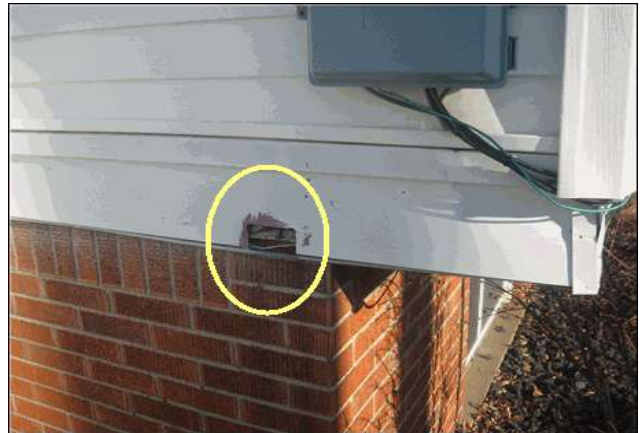
2.2.3 Exterior Wall &amp; Trim Conditions

Missing siding on west front corner of home.  
 Missing siding on east front corner of home.  
 Hole and damage on west middle of home.  
 Missing siding on rear west corner of home.

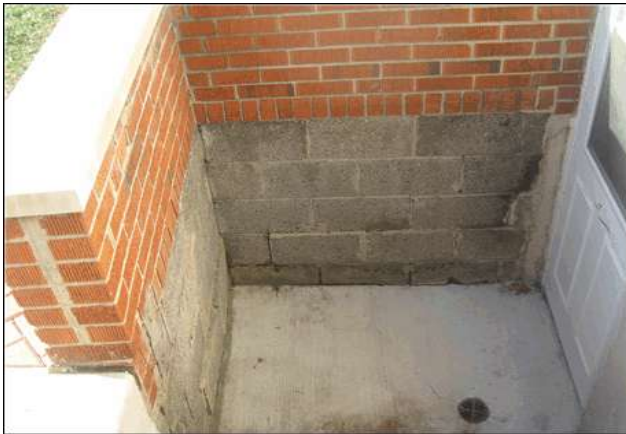
2.7.4 Railing System

SA None

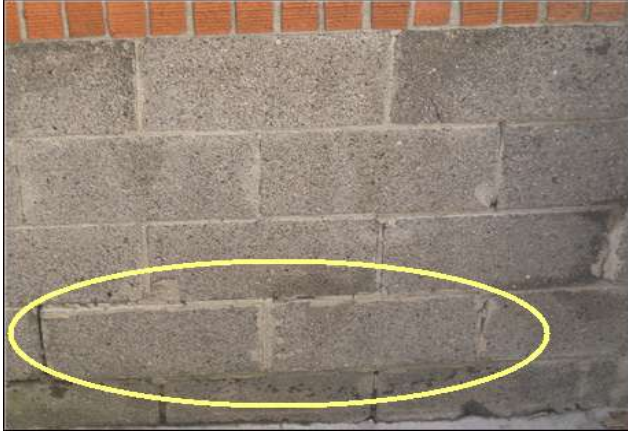
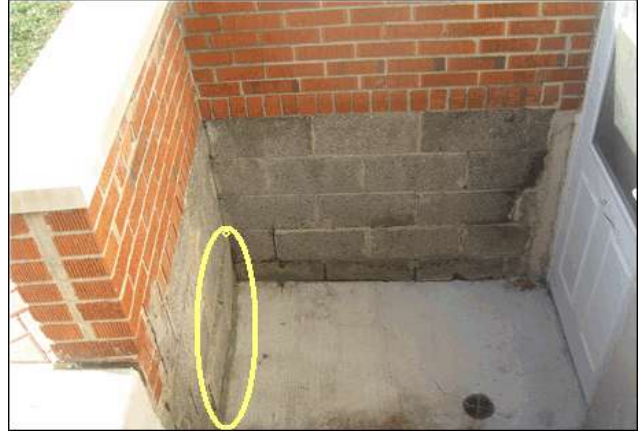
Needs repaired. Some cinder blocks are pushed out.

2.7.5 Rear Entrance Condition

Retaining wall is failing

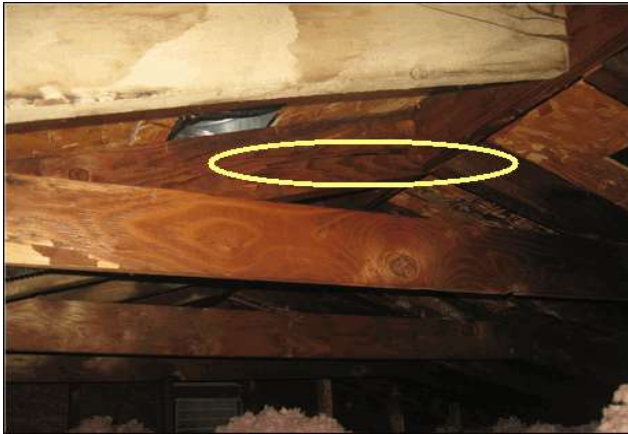
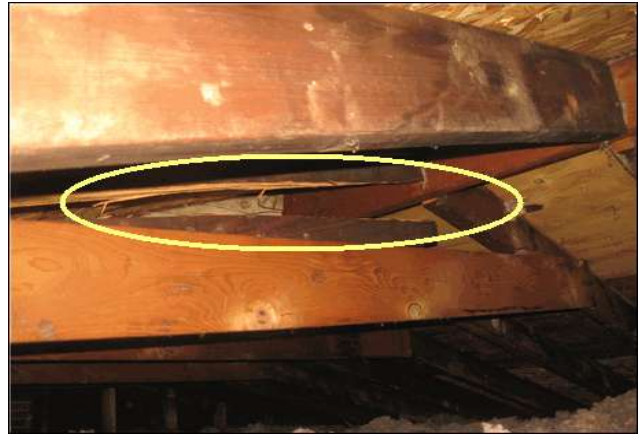
3.2.4 Roof Frame Condition

Overall good but two of the rafters were cracked.

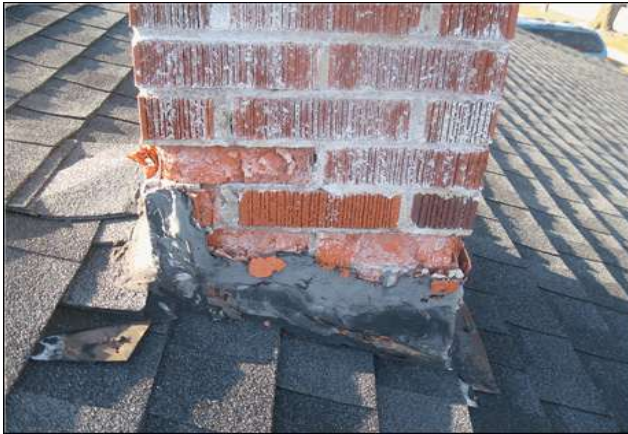
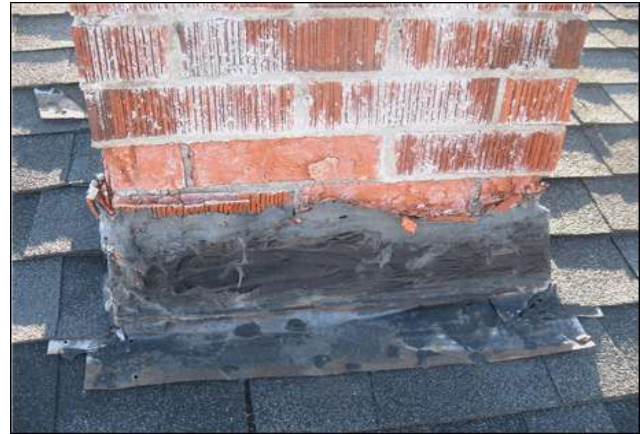
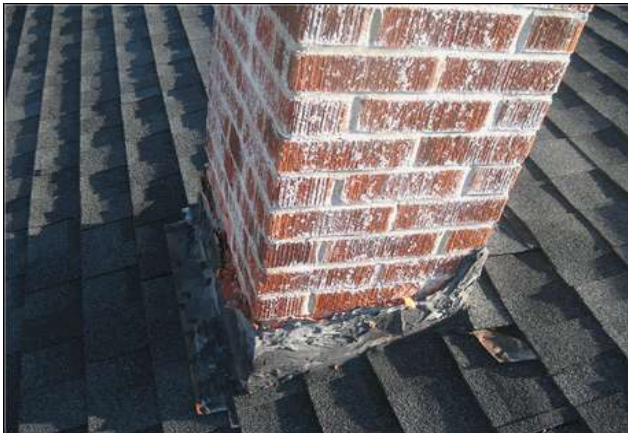
**3.3.2 Chimney Condition**

Poor at the base

Brick and mortar decay

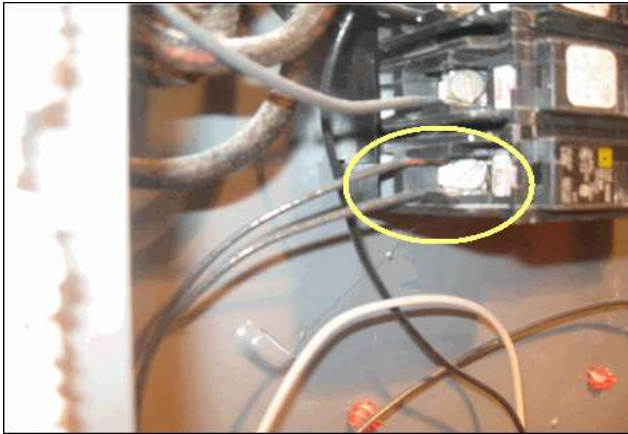
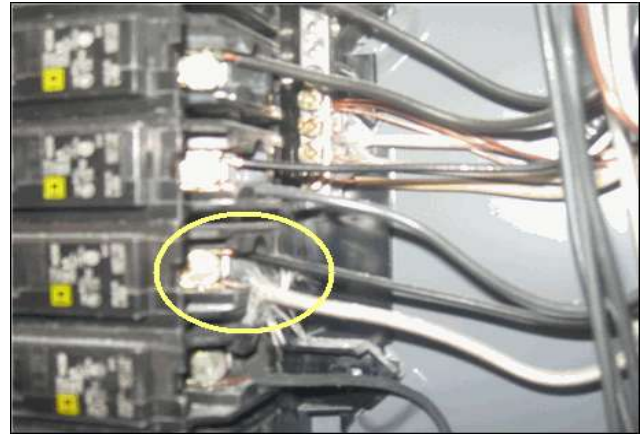
5.2.7 Wires Entering Panel  **SA** Good, no visible damage  
Also some wires share the same breaker.  
Recommend one wire per breaker.

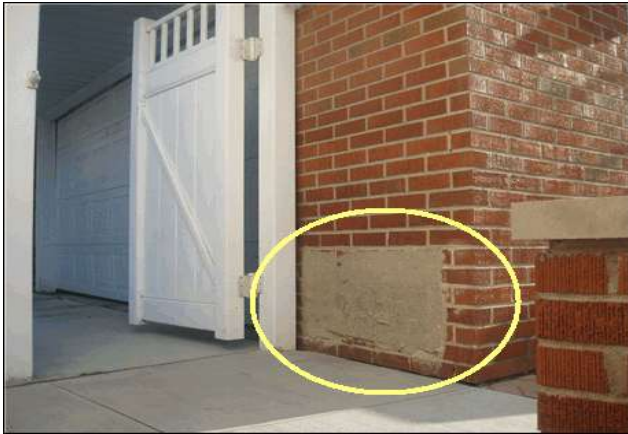
7.1.4 Wall Conditions

Wall has been patched, unknown reason

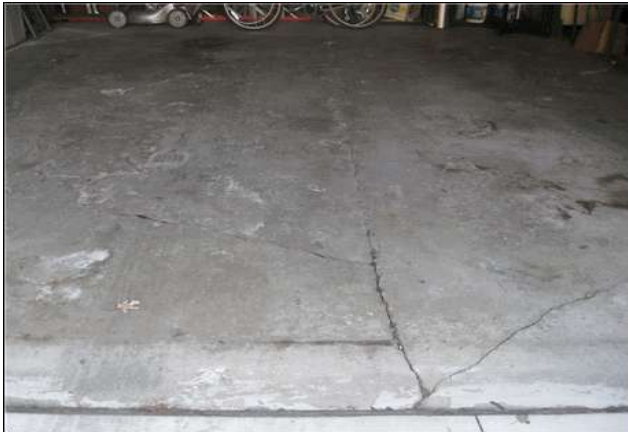
7.1.6 Floor Conditions

Poor, several cracks.

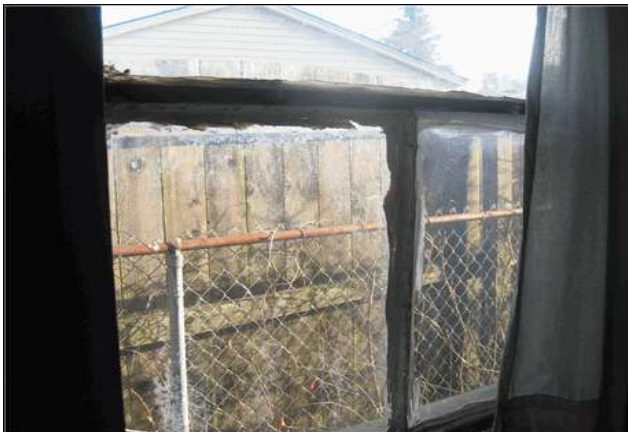
**7.1.7 Window Conditions**

Recommend window replacement

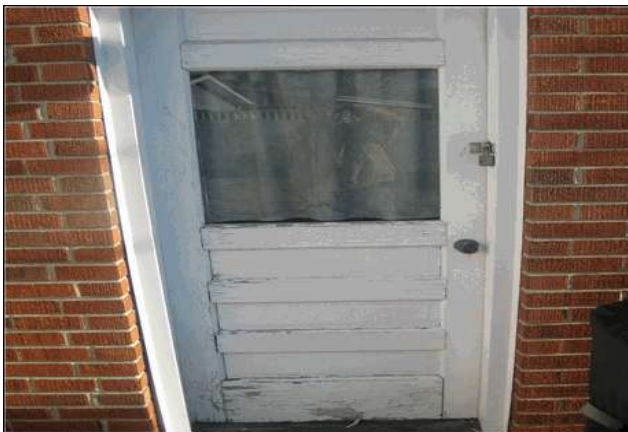
**7.1.8 Door Conditions**

Door will need to be refinished.

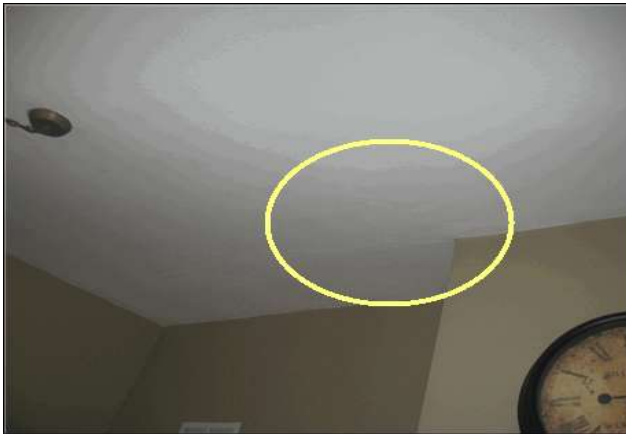
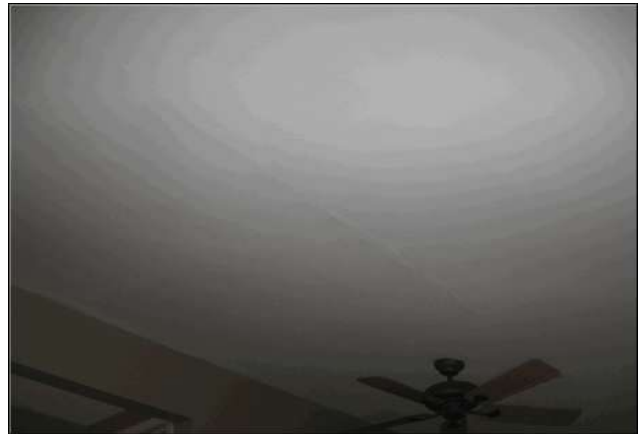
13.1.2 Ceiling Condition

Good condition  
Some evidence of possible water damage.

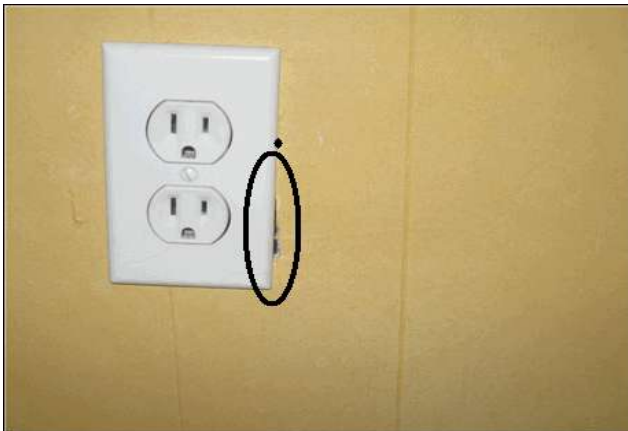
**14.2.1 Outlet condition**

Some cut outs for outlets are bigger than wall plate
